DRAFT INTERIM TEST RESULTS REPORT FOR BIOVENTING TEST WORK PLAN FOR FIRE TRAINING PIT 1 AND SPILL SITE 1 F.E. WARREN AFB, WYOMING

Engineering-Science, Inc.

August 1992

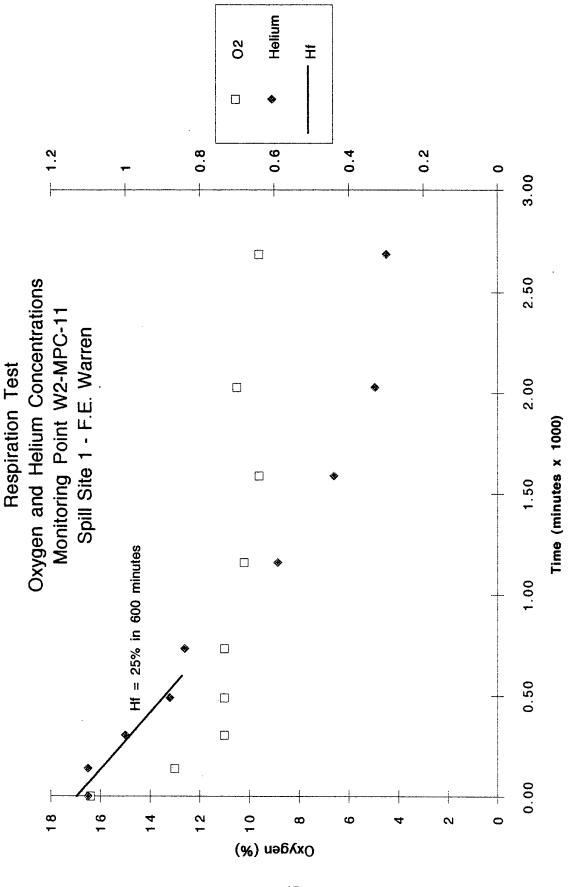
Figure 1.9

in a fractional loss of approximately 25 percent of the initial helium concentration (Figure 1.9). Due to oxygen's greater molecular weight, helium will diffuse approximately three times faster than oxygen. This means that at MPC-11, approximately 8 percent of the initial oxygen may have been lost due to diffusion during the initial 600 minutes. Table 1.5 provides a summary of the observed and corrected oxygen utilization rates for Spill Site 1. As these MPs were all completed in the same soil formation, oxygen diffusion rates for MPA-11 and MPB-11 were assumed to be similar to the rate estimated for MPC-11. It is interesting to note that virtually all of the oxygen lost from MPA-11 was due to diffusion, based on the helium/oxygen diffusion estimate.

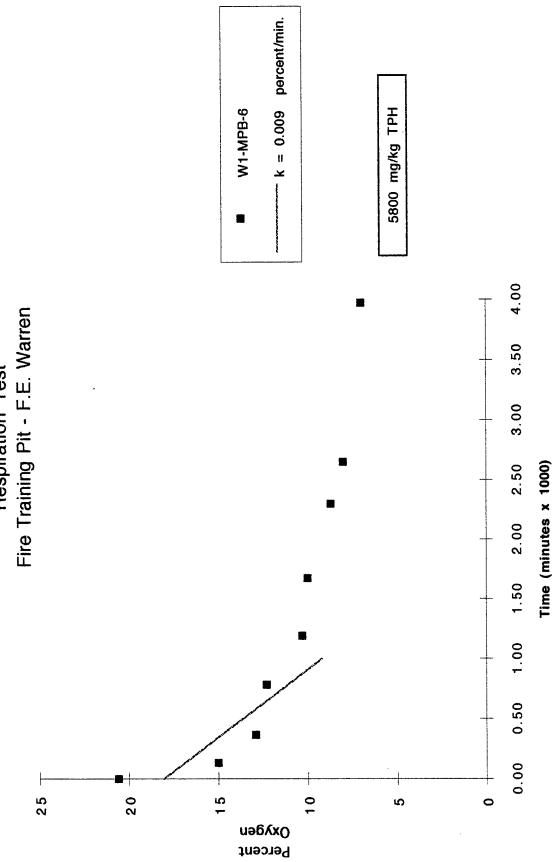
Figure 2.7 Respiration Test Fire Training Pit - F.E. Warren

The results of *in situ* respiration testing at Fire Training Area 1 are presented in Figures 2.5 through 2.8. Oxygen loss from MPA-6 occurred at the fastest rate. This MP also had the lowest initial oxygen concentration. MPB-7 and MPC-6 exhibited

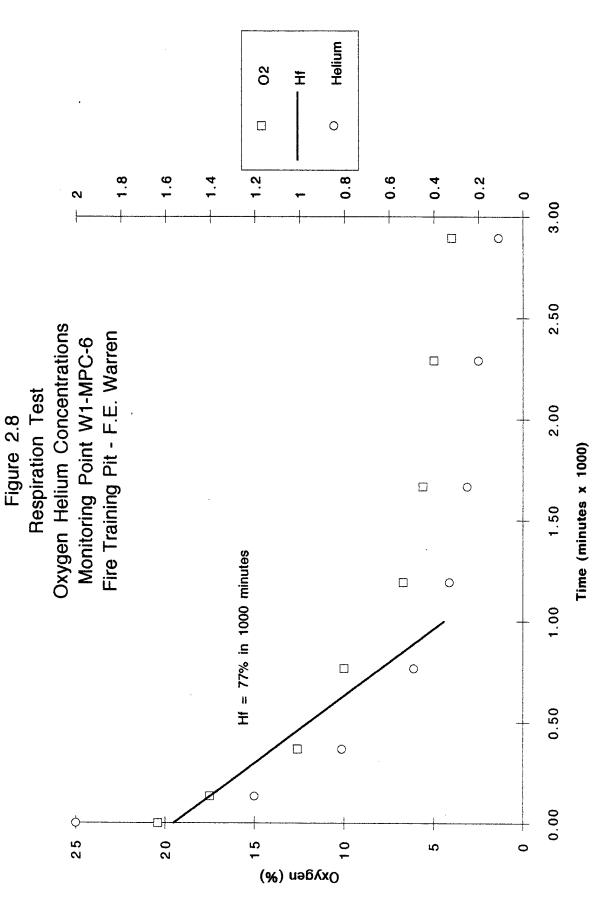
O2/Helium FTP - FE Warren

similar oxygen losses during the first 1,000 minutes of the test, however, the rate of oxygen loss slowed more rapidly in MPB-7. It is possible that MPB-7 is located on the boundary of an oxygen-rich zone, it had an initial oxygen level of 6.0 percent yet had a TPH value of 5,800 mg/kg. A leak in the MP valve could also have occurred. This MP will be carefully checked and leak tested prior to the next respiration test. During the initial 1000 minutes, helium diffusion at MPC-6 resulted in a fractional loss of approximately 77 percent of the initial helium concentration (Figure 2.7). Due to oxygen's greater molecular weight, helium will diffuse approximately three times faster than oxygen. This means that at MPC-11, approximately 26 percent of the initial oxygen may have been lost due to diffusion during the initial 1,000 minutes. Table 2.5 provides a summary of the observed and corrected oxygen utilization rates for the Fire Training Area 1. Due to similarity in surrounding soils, the oxygen diffusion rate for MPB-6 and MPA-6 were assumed to be similar to the rate estimated for MPC-6.
